HYDRAULIC MODEL STUDIES OF THE
SPILLWAY AND OUTLET WORKS
FOR PRINEVILLE DAM
CROOKED RIVER PROJECT, OREGON

Hydraulic Laboratory Report No. Hyd-452

June 1, 1959

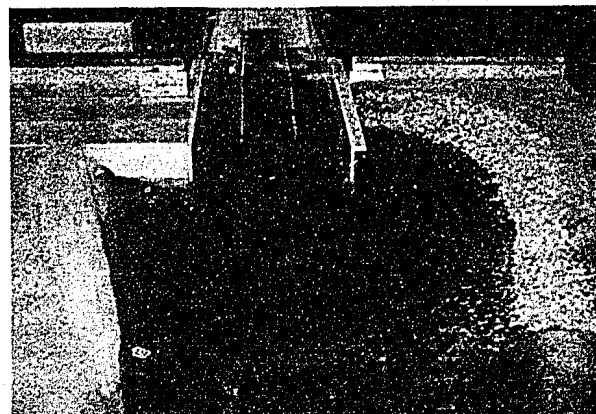
Figure 13
Report Hyd 452

$Q = 1,000 \text{ cfs}$ $TW = 3078.7$

$Q = 3,000 \text{ cfs}$ $TW = 3081.8$

PRINEVILLE SPILLWAY AND OUTLET WORKS
Low Spillway Flows in Recommended Stilling Basin
1:24 Scale Model

The performance of the stilling basin with spillway flows was satisfactory (Figures 13 and 14). A slightly higher water surface was noted in the upstream end of the center section of the basin than in the left and right bays (Figure 12G). This occurred because the water in the central portion of the spillway chute passes over the outlet conduit opening. The lack of support at the opening allows the water to fall on a free trajectory and impinge on the invert of the outlet chute. This impingement disrupts the flow to some extent, with the result that the toe of the jump in the center bay is not swept as far downstream as in the side bays.

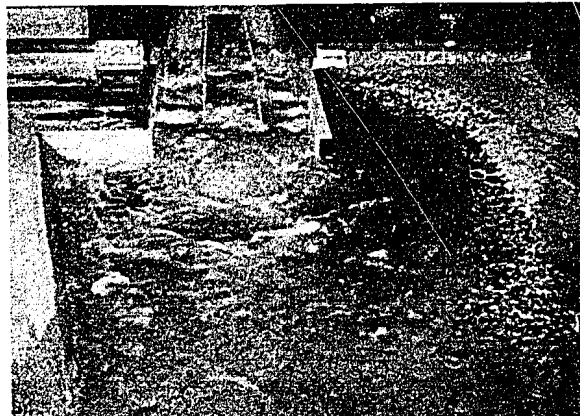
$Q = 6,000 \text{ cfs}$ $TW = 3084.7$

$Q = 8,120 \text{ cfs (max.)}$ $TW = 3086.4$

PRINEVILLE SPILLWAY AND OUTLET WORKS
High Spillway Flows in Recommended Stilling Basin
1:24 Scale Model

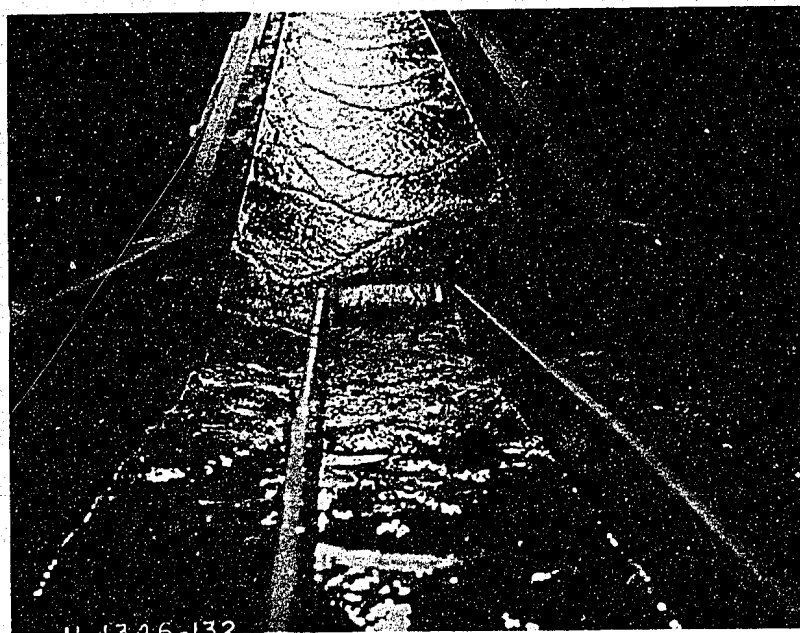
A. The smooth sheet of water at the crest roughens and develops into progressively larger roll waves

B. The roll waves strike the stilling pool and cause considerable splashing and wave action

PRINEVILLE SPILLWAY AND OUTLET WORKS
Roll Waves in Spillway
 $Q = 300$ cfs
1:24 Scale Model

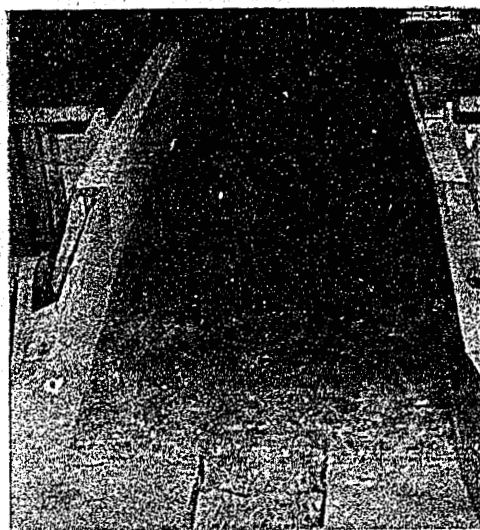
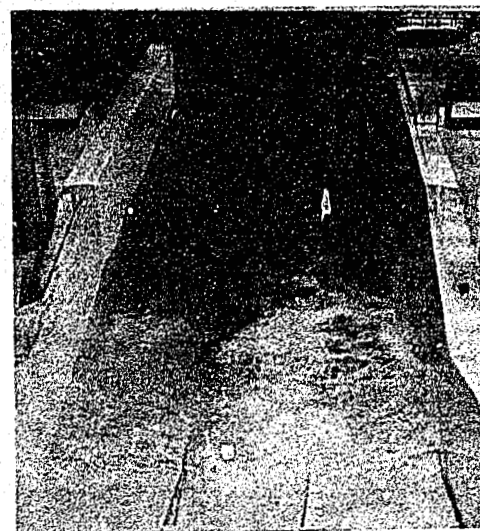
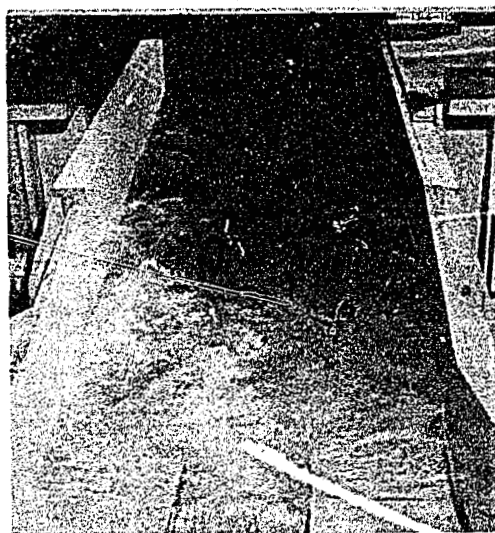
Basin Without Walls

$Q = 800$ cfs Both Gates 5'-6" open

$Q = 800$ cfs, Gates throttled, full res.

$Q = 1,600$ cfs Both gates 5'-6" open

$Q = 1,600$ cfs, Gates throttled, full res.

$Q = 3,529$ cfs Both gates 5'-6" open

PRINEVILLE SPILLWAY AND OUTLET WORKS
Outlet Flows in Stilling Basin Without Dividing Walls
1:24 Scale Model

Tests showed that intermediate dividing walls within the basin were essential for properly handling the outlet works flows. No hydraulic jump formed when there were no walls to restrain the flow, and the jet continued through the basin. In addition, the jet was unstable and moved to one side or the other of the basin and formed a strong eddy that pulled riverbed material into the basin (Figure 23). The energy dissipation was poor, the wave action great, and the river channel erosion severe. The only flow conditions that were in any way acceptable were low discharge at moderate and low velocities.

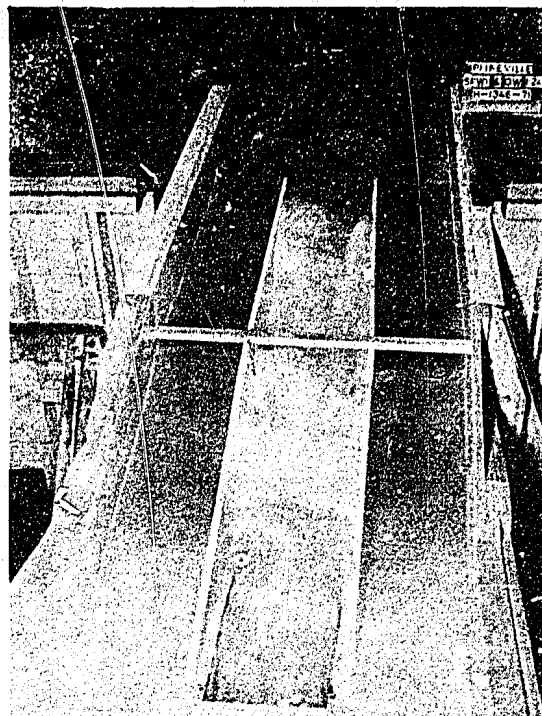
$Q = 1,800$ cfs Left Gate only; open 5'-6"

$Q = 3,529$ cfs Both gates 5'-6" open

$Q = 3529$ cfs Both Gates open 5'-6"

PRINEVILLE SPILLWAY AND OUTLET WORKS
High Outlet Flows in Recommended Stilling Basin
1:24 Scale Model

5. Dividing walls in the stilling basin are essential for outlet works flows (Figure 23). The initially proposed 28.5-foot high walls extending to Station 13+41.67 are satisfactory, and the basin performance is good (Figures 24 and 25).

With the 28.5-foot high walls installed, the flow conditions were good (Figures 24 and 25). A good hydraulic jump formed with satisfactory energy dissipation and flow redistribution. The wave action in the river channel was appreciable, but not excessive at discharges above about 2,500 cfs. At a discharge of 3,529 cfs, the maximum trough-to-crest height, as scaled up from the model, was about 3 feet, and the average wave height was about 1-1/2 feet.

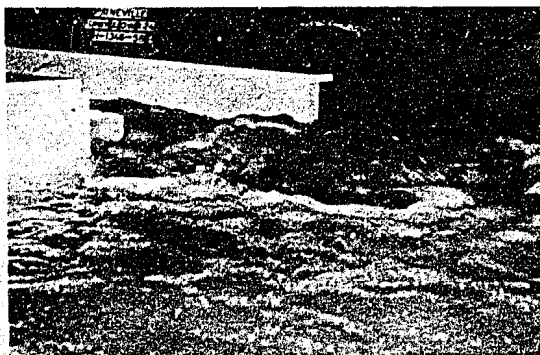
D. Walls 18 feet high extended
to end of basin. $Q = 4,080$ cfs

PRINEVILLE SPILLWAY AND OUTLET WORKS
Flow Conditions and Sand Deposits in Stilling Basin
With and Without Dividing Walls
1:24 Scale Model

When the height of the wall extensions was reduced to 18 feet, water poured in over the wall tops. The jump moved upstream a little, and the violence of the boil was reduced slightly (Figure 26D). In spite of these small changes, the flow conditions and waves were still too rough to be acceptable. Furthermore, large quantities of riverbed material were deposited in the basin (Figure 26B).

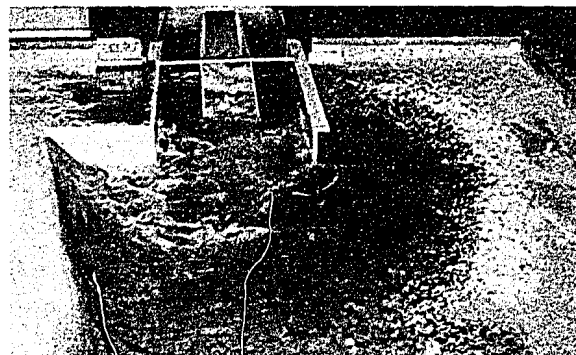
B. Flow Conditions with Recommended Walls. $Q = 3,529$ cfs

PRINEVILLE SPILLWAY AND OUTLET WORKS
Outlet Flow Conditions, and Scour With 2:1 Riprapped
Slope Downstream from Basin
1:24 Scale Model
